## TIHONET POND NO. 2 DAM

MA 00030

# PHASE I INSPECTION REPORT NATIONAL DAM INSPECTION PROGRAM

JULY 1981

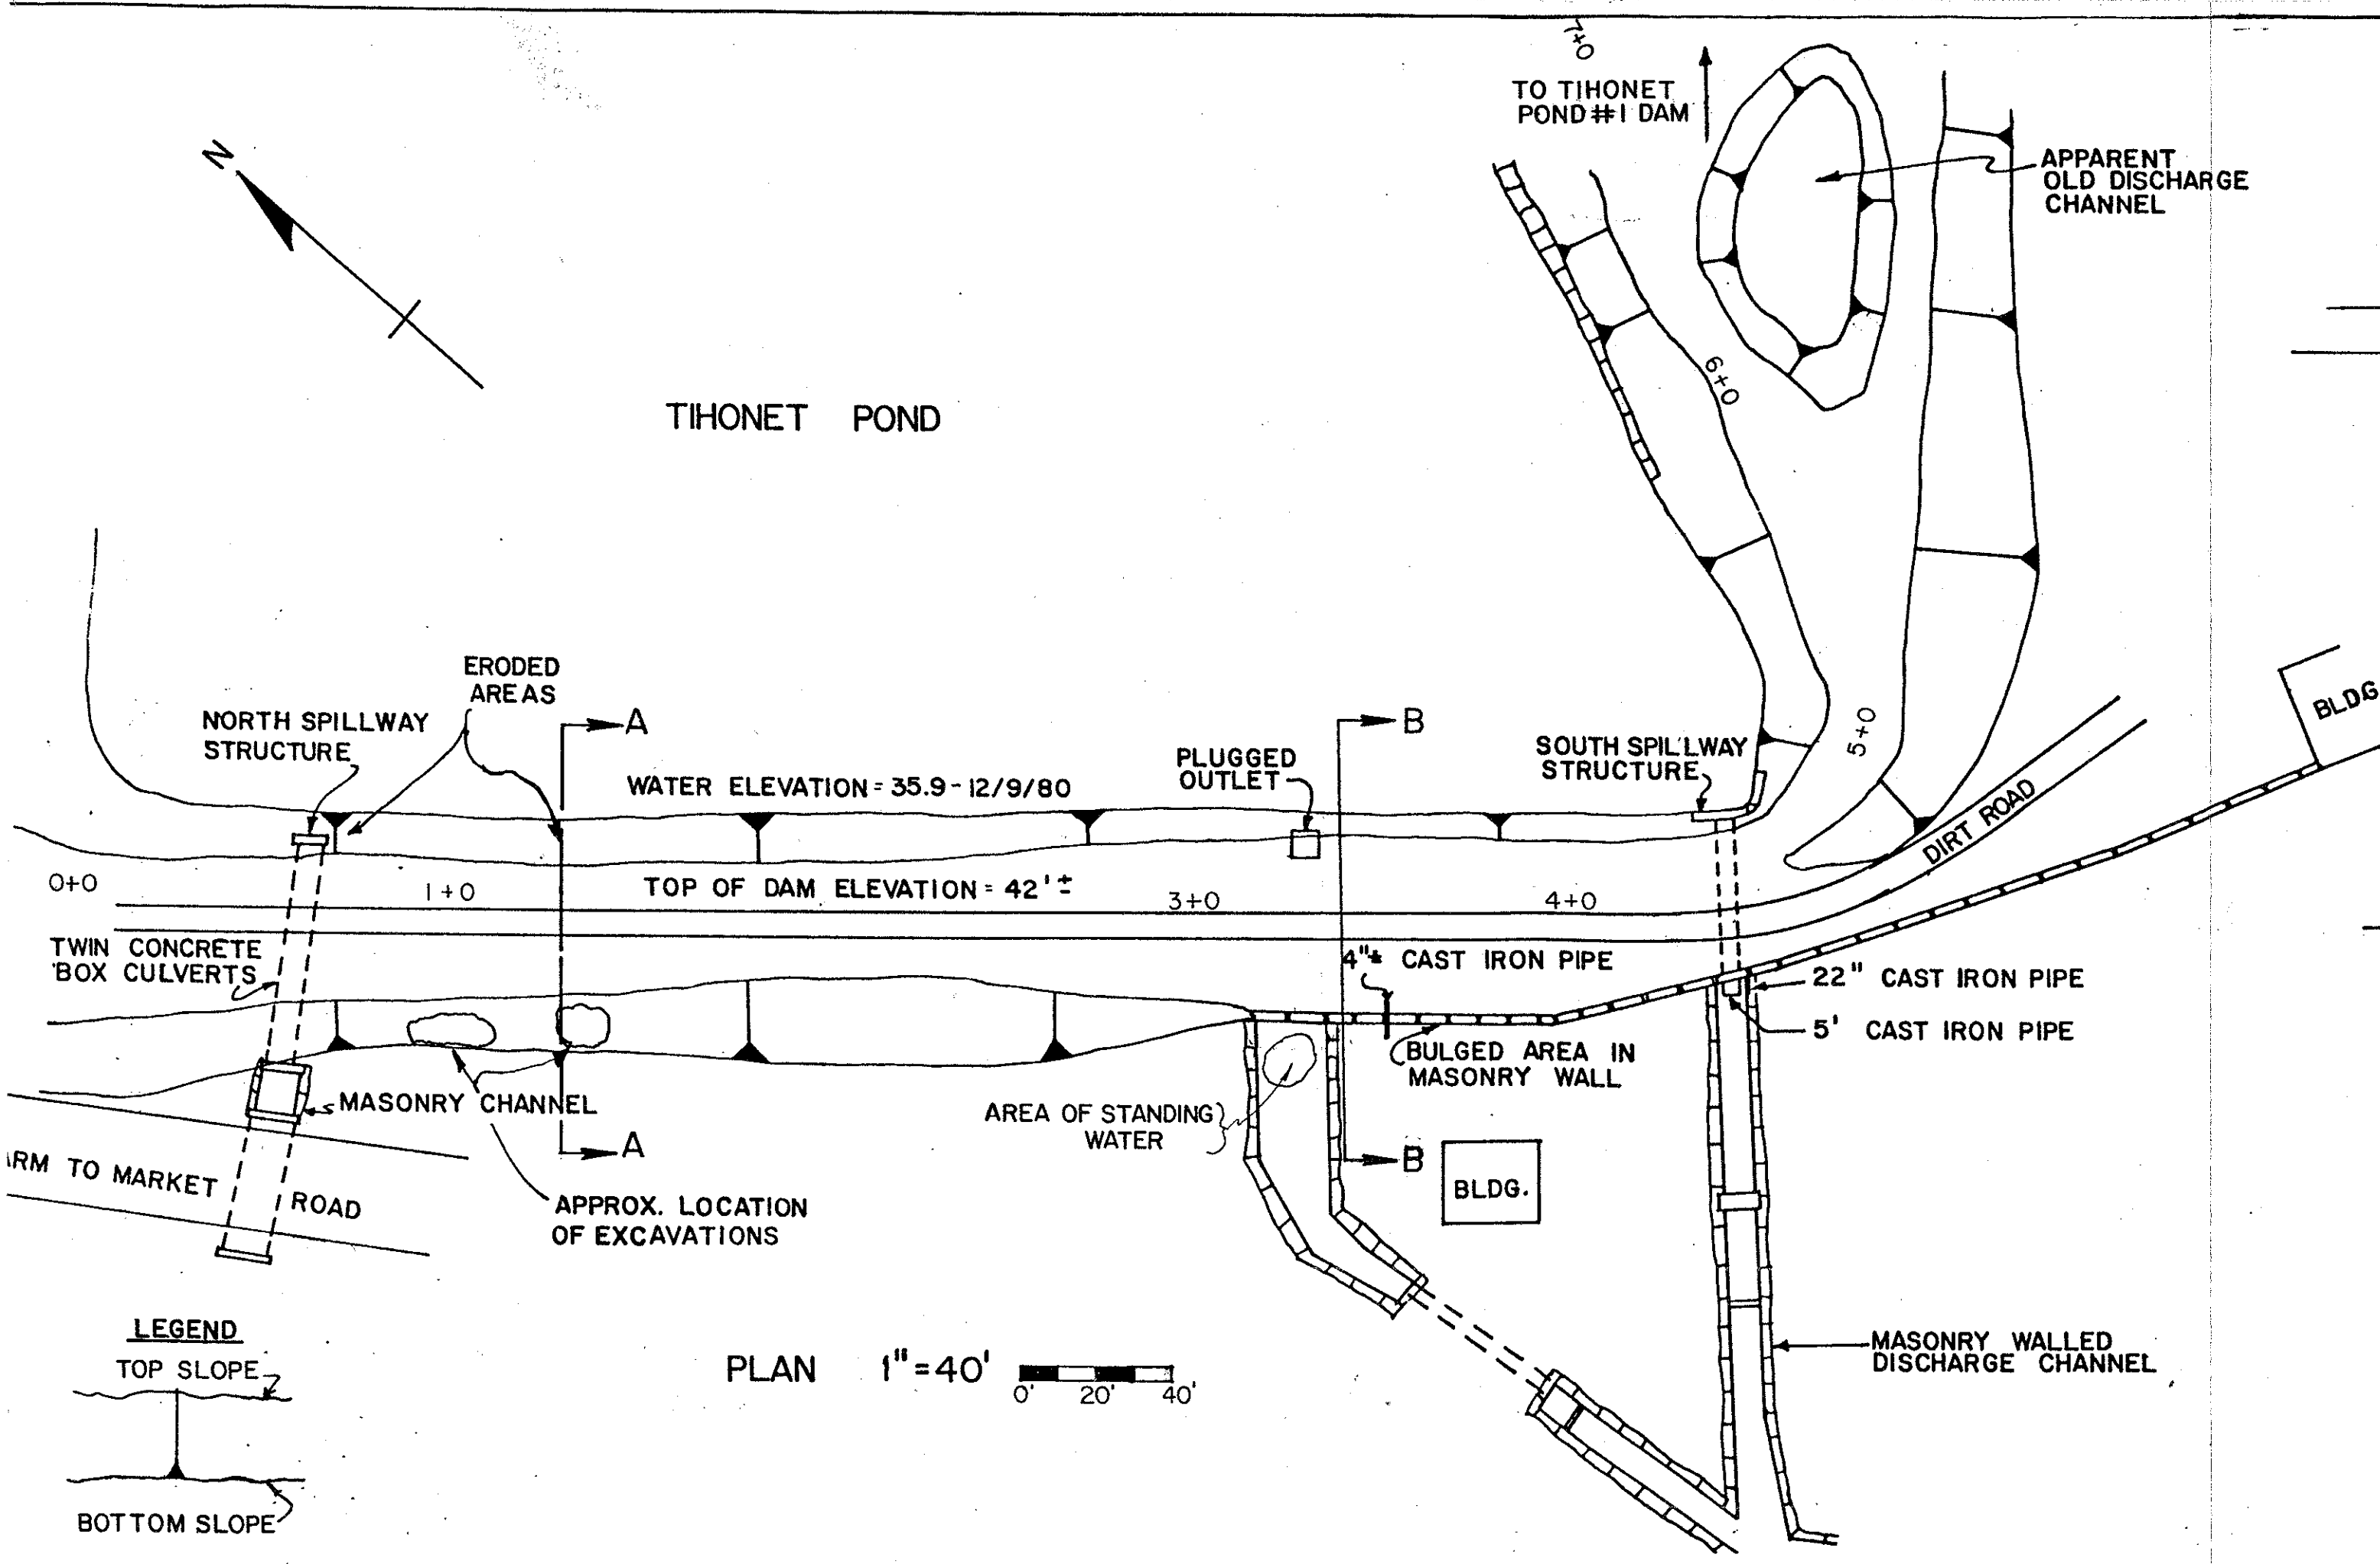
FIG. 2

No design plans were reviewed, however inspection sketches reviewed appear to represent fairly existing conditions at the time of the visual inspection.
